CANADA'S MINING HERITAGE – BALANCING THE HERITAGE PRESERVATION WITH THE ENVIRONMENT, HEALTH AND SAFETY¹

Charles Dumaresq²

Abstract: When developing and implementing mine closure plans at most mine sites in Canada, there is no need to consider the heritage value of mining structures or other features, such as mine head frames. In general, structures are removed at the end of the mine life, and sites returned to something resembling the pre-mining state. However, at some sites, heritage considerations can make mine closure more complex. In Cobalt, Ontario, abandoned silver mines are subject to a mine closure plan and at the same time many of the mines are part of a National Historic Site and are the focus of efforts to increase tourism in the area. This presents challenges for reclamation and can leave those concerned about reclamation at odds with those concerned about heritage. However, the two need not be seen as mutually exclusive. In Cobalt, efforts have been made to preserve historic head frames, mill foundations, and other signs of Cobalt's heritage. At the same time, efforts have been made to assess the potential health risks to visitors to these sites, due to concerns abou

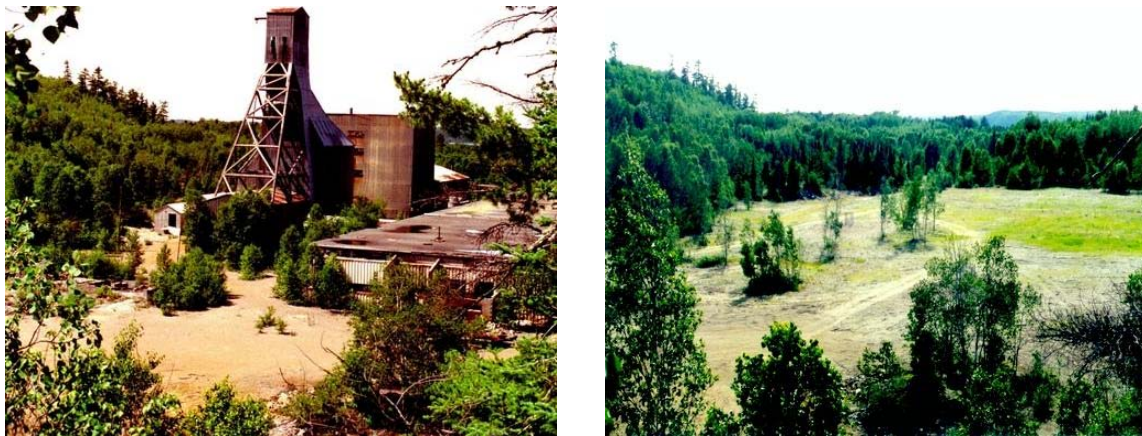
Fig. 1: The North Coldstream Mine near Burchell Lake in Ontario. Taken in 1993 (left) and 2001 (right), the photos illustrate the extent of mine reclamation work carried out on the site by the Ontario Ministry of Northern Development and Mines (photo credit: Ontario Ministry of Northern Development and Mines).

While removal of buildings is not required in Ontario, mine closure at most sites does include the removal of buildings. For example, the headframe and other buildings of the North Coldstream Mine were removed and the site was revegetated (Fig. 1) under the Abandoned Mines Rehabilitation Program of the Ontario Ministry of Northern Development and Mines. At most sites this approach is not a concern, and makes the most sense in the context of the objectives of mine closure. However, this practice becomes problematic when these structures are also heritage resources.

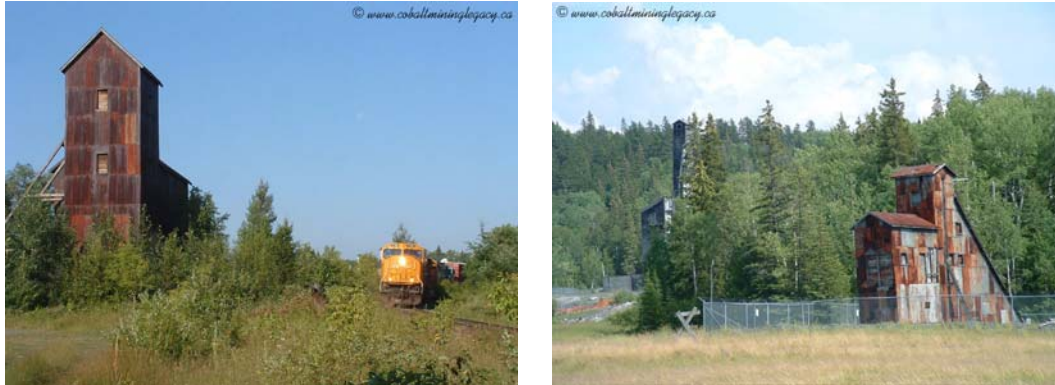
Fig. 2: Cobalt mine headframes, both now almost 100 years old (photo credit: the author).

There has been progress in meeting this challenge in Cobalt. Despite the loss of the O'Brien Mine headframe and several others, many, such as those illustrated in Figure 2 have been preserved. At the same time, some tailings deposits have been remediated in an effort to reduce releases of As, reducing risks to the environment and human health. However, significant challenges remain. Mill foundations pose a significant challenge, particularly those that are contaminated with As and other metals.

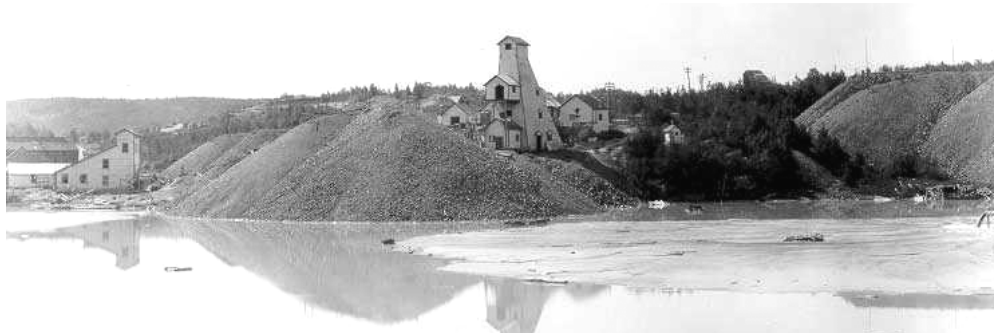
Fig. 3: Typical waste rock disposal practices in the early silver mines of Cobalt (photo credit: Canada Museum of Science and Technology).

Mining in Cobalt also left an environmental legacy. Waste rock and tailings were disposed of with no regard for the environment. Waste rock was disposed of in dumps that extended outwards from mine headframes (Fig. 3). Tailings were dumped in the closest convenient depression in the land, including lakes and streams (Fig. 4). Waste rock and tailings are high in As because the ore in Cobalt was associated with arsenide and sulfarsenide minerals. Arsenic continues to leach from these wastes and most of the lakes and streams around Cobalt are laden with As. Despite recent remediation projects, Cobalt remains one the largest sources in Canada of releases of As. Estimates of the annual releases of As into Lake Temiskaming range from 10,000 to 18,000 kg – more than all metal mines operating in Canada in 2003, combined. (Beak 2002; Dumaresq, 1993; and Environment Canada, 2006).

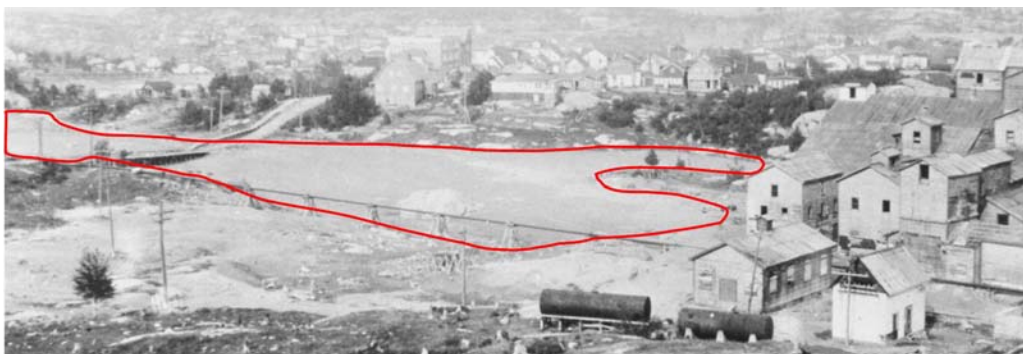
Fig. 4: Typical tailings disposal practices in the early silver mines of Cobalt. Tailings from the mill are outlined in red (photo credit: Cobalt Mining Museum).

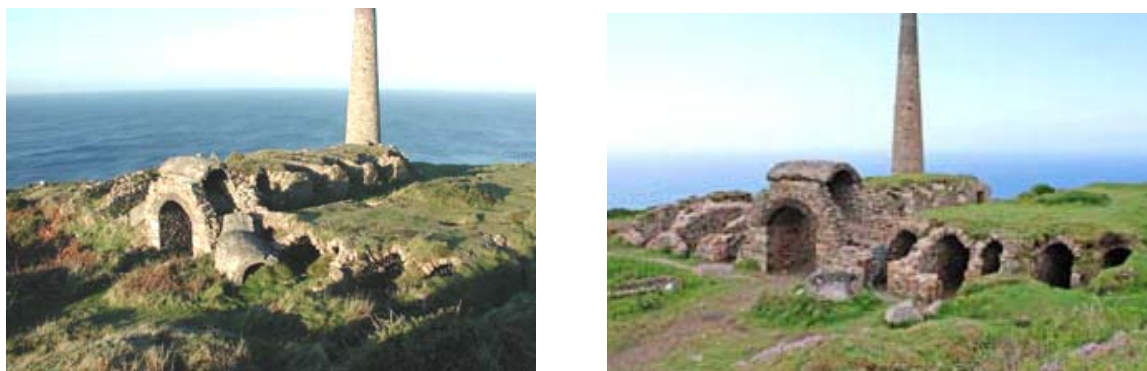
Fig 6: The Botallack labyrinth As works in Cornwall, UK, before (left) and after (right) remediation and site restoration (photo credit: Cornwall County Council).

In preparation for site remediation and restoration, samples were collected within and around the labyrinth to assess As concentrations. Within the labyrinth As concentrations ranged from 87 to 25,920 mg/kg. Arsenic concentrations were highest within the interior of the labyrinth itself, as well as in soils next to the chimney. This was attributed to the fact that these areas were less exposed to weathering (Sharpe, in press). For comparison, As concentrations in 15 samples from two mill sites that are part of

Prior to remediation a risk assessment was undertaken and procedures were established to ensure the safety those involved in the remediation work. To remediate the site, hand and machine excavation was used to remove As-bearing materials. The walls of the labyrinth were then scraped and finally cleaned with a high pressure washer. All wastes from the remediation work were collected and disposed of appropriately. To prevent exposure to any residual As the floors of the labyrinth were then covered with a geotextile fabric and a layer of clean material (Sharpe, in press). Once the remediation work was complete and the site was safe for both workers and tourists, restoration work was carried out (Fig. 6).

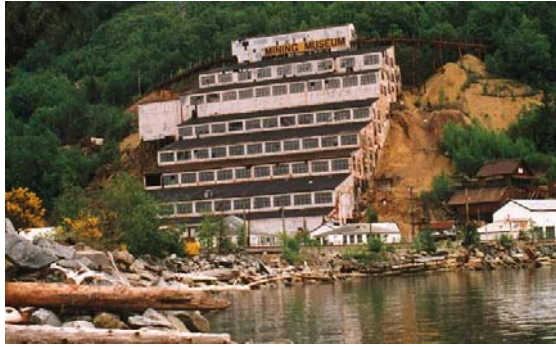
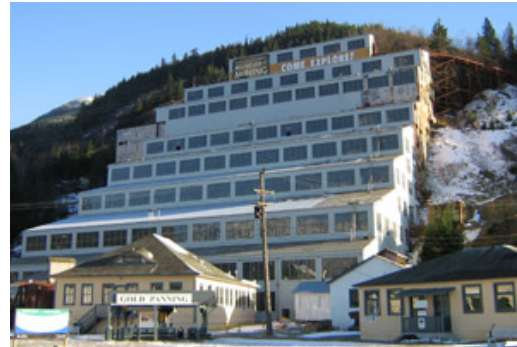
Fig. 7: The Britannia Mill before and after restoration (photo credit: BC Museum of Mining)

These remediation activities were implemented in a manner that respected the heritage resources of the site. But concurrent with the implementation of the mine closure plan, the mill structure has been restored as the first phase of an overall rehabilitation of the historic site. This project is seen as an “opportunity to prove that an environmental liability can be transformed into a social, economic and environmental asset – a legacy that Canadians and the mining industry can be rightly proud of and pass on to future generations” (Britannia Project Team, 2004). The restoration of the mill, now largely complete, is the cornerstone of this project (Fig. 7). One aspect of this project will be public education, which will include an emphasis on the environment and sustainable policies, practices and technologies. Thus, at Britannia, the environmental legacy of the site will be addressed head on and the environmental legacy and the work done to remediate the site and thereby address this legacy, will be a key aspect of the project.
